ONONDAGA DAM
NEW YORK
INVENTORY No. NY 794

PHASE I INSPECTION REPORT
NATIONAL DAM SAFETY PROGRAM

PHASE I INSPECTION REPORT
ONONDAGA DAM I.D. NO NY 794
OSWEGO RIVER BASIN
ONONDAGA COUNTY, NEW YORK

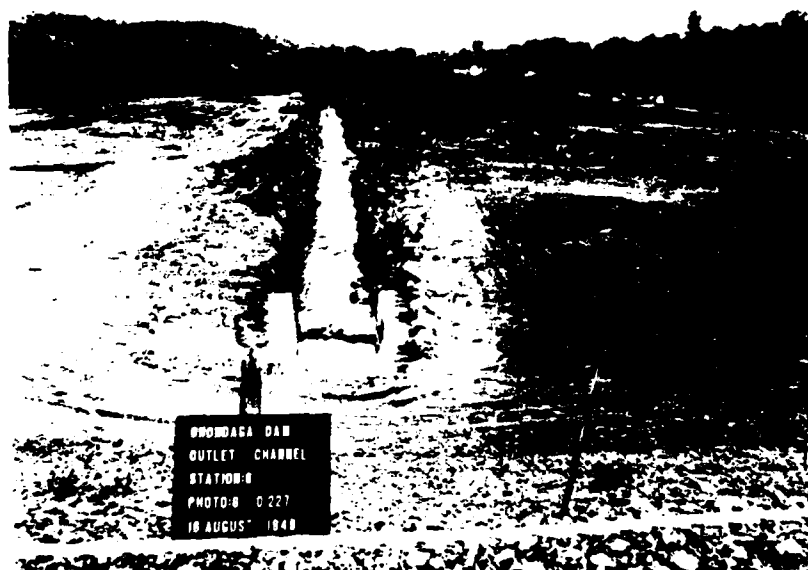
Outlet works - Intake channel and structure.

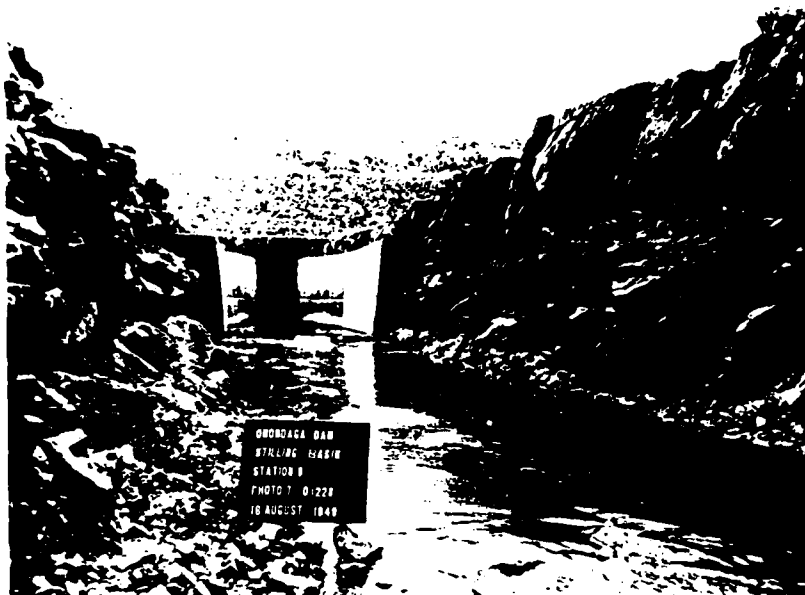
Grondaga Dam - Spilling basin and outlet tunnel end structure

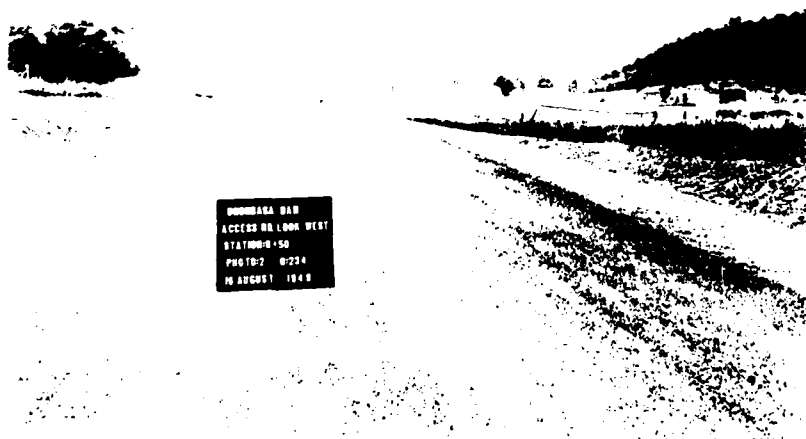
Looking west from station 40

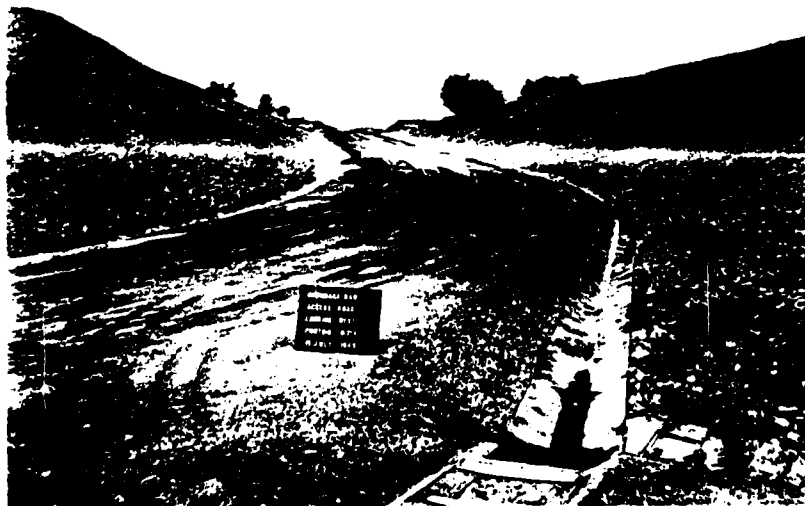
Reinforced concrete cattle pass

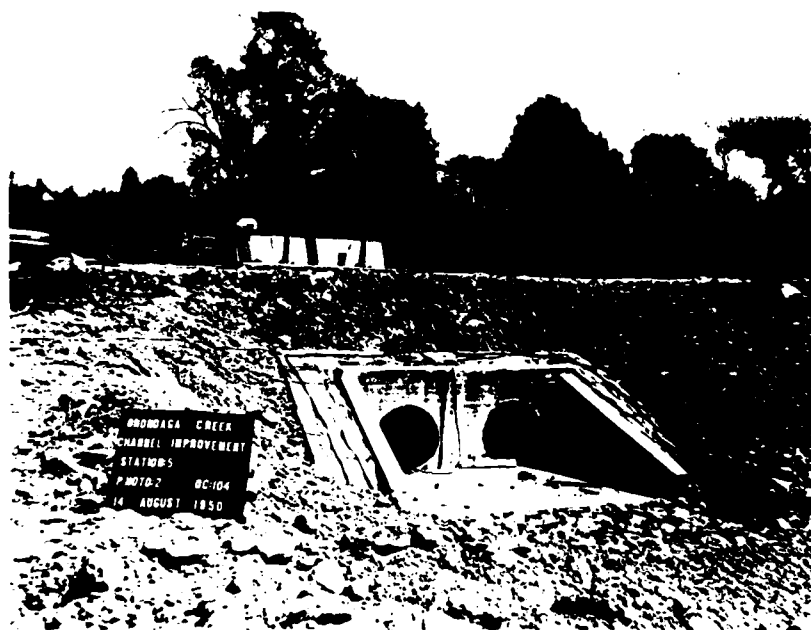
Channel improvement project, Rockwater Creek, Station 5, August 14, 1950.

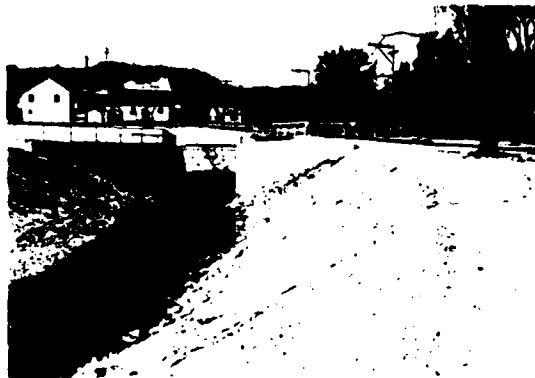
Channel, Elmore, N. H. looking
looking westward, showing
old, better, and improved
improved channel.

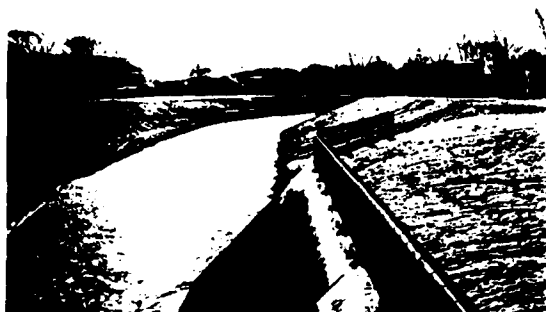
Looking upstream from
Ballantyne Road Bridge

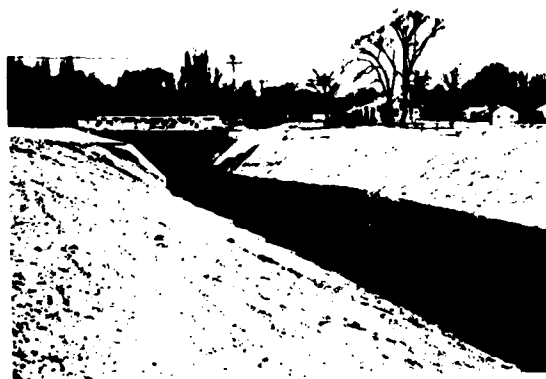
Looking downstream toward
Ballantyne Road Bridge and
concrete flume

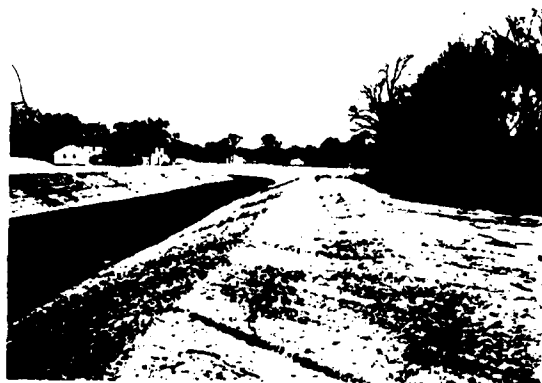
Looking downstream from right bank
midway between Ballastyne Road and
West Canada Turnpike

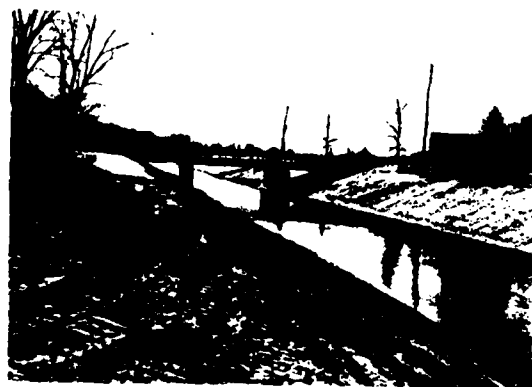
Looking upstream from right
bank towards new West Canada
Turnpike highway bridge
